**QUALIFICATION TEST REPORT ABSTRACT  
FOR  
STAR-PAN™ VI DATA AND POWER  
6 PORT HUB 808-037**

**REPORT NO. GT-19-180 ABSTRACT**

**QUALIFICATION TEST REPORT**  
**STAR-PAN™ 6 Port Hub**  
**Part No. 808-037**

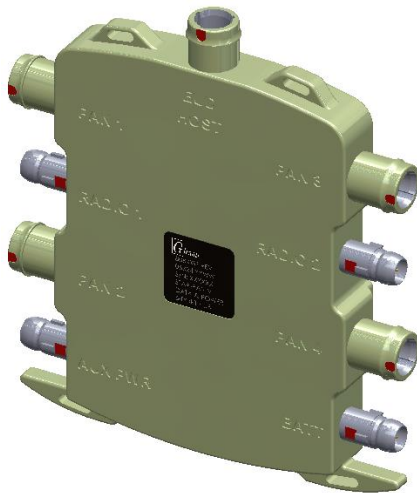
**Front View  
6 Port Hub**

Glenair 808-037 STAR-PAN™ 6 Port Hub is a USB hub with integrated power management functions for supplying power to connected devices. Its rugged construction is intended for tactical applications in hostile environments. The 6 Port Hub, subjected to a series of environmental and mechanical tests, is designed to meet the requirements of MIL-STD-810G-CHG 1 while utilizing lightweight aluminum alloy housing and high conductivity gold plated copper alloy contacts.

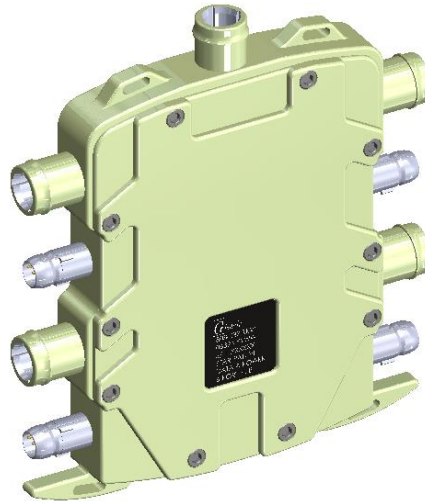
**Rear View  
6 Port Hub**
